IRON BRIDGE AT LOCK #68

HISTORIC STRUCTURE REPORT

CHESAPEAKE AND OHIO CANAL NATIONAL HISTORICAL PARK

ARCHITECTURAL DATA

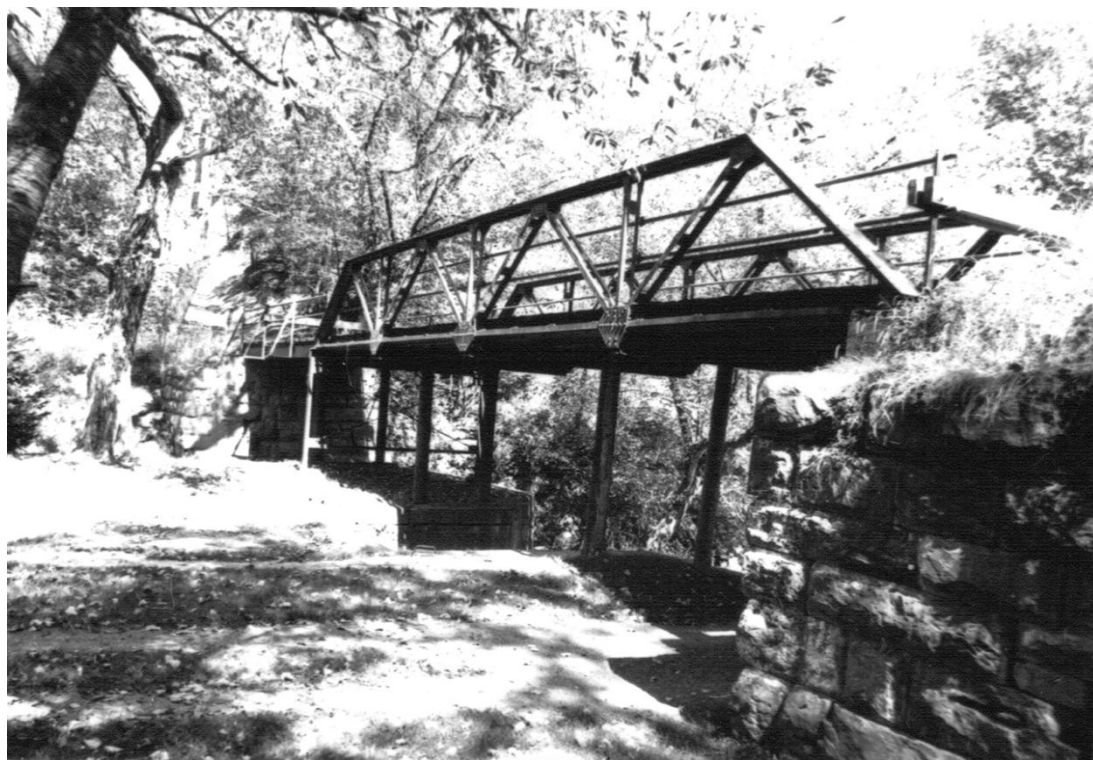
1. The iron bridge over Lock No. 68.
View from outside the towpath at upriver side of abutment.

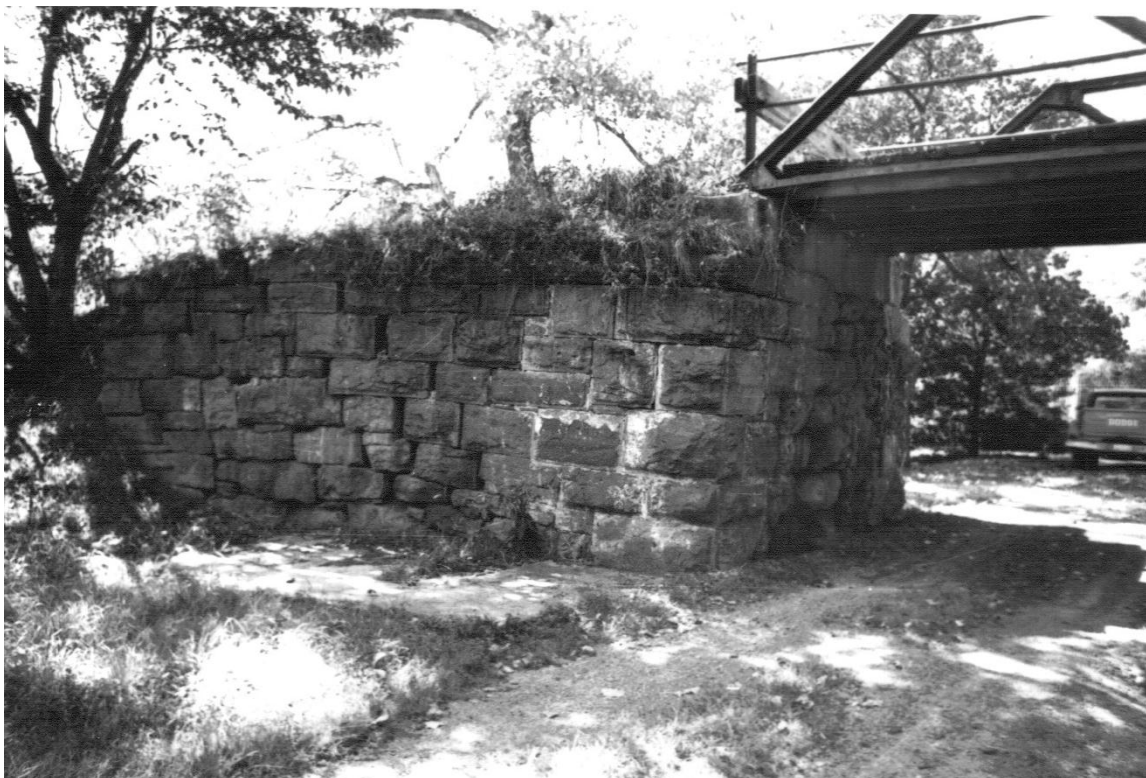
Both stone abutments are found to be inconsistent with the majority of the masonry work in the canal. The prevalent pattern found on this structure is coursed fieldstone and rough rubble. The corner stones show that they need some stabilization. Deterioration of stone voids in the walls, and joints lacking mortar are evident. The possibility of finding voids inside the abutments is strong. Considerable settlement is obvious due to uneven lines of stonewalls, joints, and horizontal and vertical cracks. Vegetation is growing rampant on these walls.

2. View of abutment from downriver side of bridge at towpath.
Note settlement and voids in stonewalls.

Before any work on the abutments is started, the bridge will be shored up. Then the major stones in the walls of this structure will be identified for re-alignment. All vegetation and loose materials will be removed from the walls of the abutments. Concrete sills that rest on top of walls facing the canal will be removed. Out-of-place stones will be removed, cleaned and re-laid on a fresh bed of mortar. All joints and small voids between existing stones will be filled with fresh mortar. Large voids will be filled with concrete, leaving a reveal of one and one half to two inches from the face of stonewalls. (This procedure will clearly identify missing stones from the structure.) Grout will be placed into voids behind stonewalls to create a monolithic mass and also to make the walls waterproof. This procedure will be done in three-foot increments starting at the bottom. After grouting is completed, new concrete sills will be poured onto top of walls facing the canal in two parts, the first being the base and the second being the sill. New bearing plates will be placed on top of the base to receive the beams of the bridge.

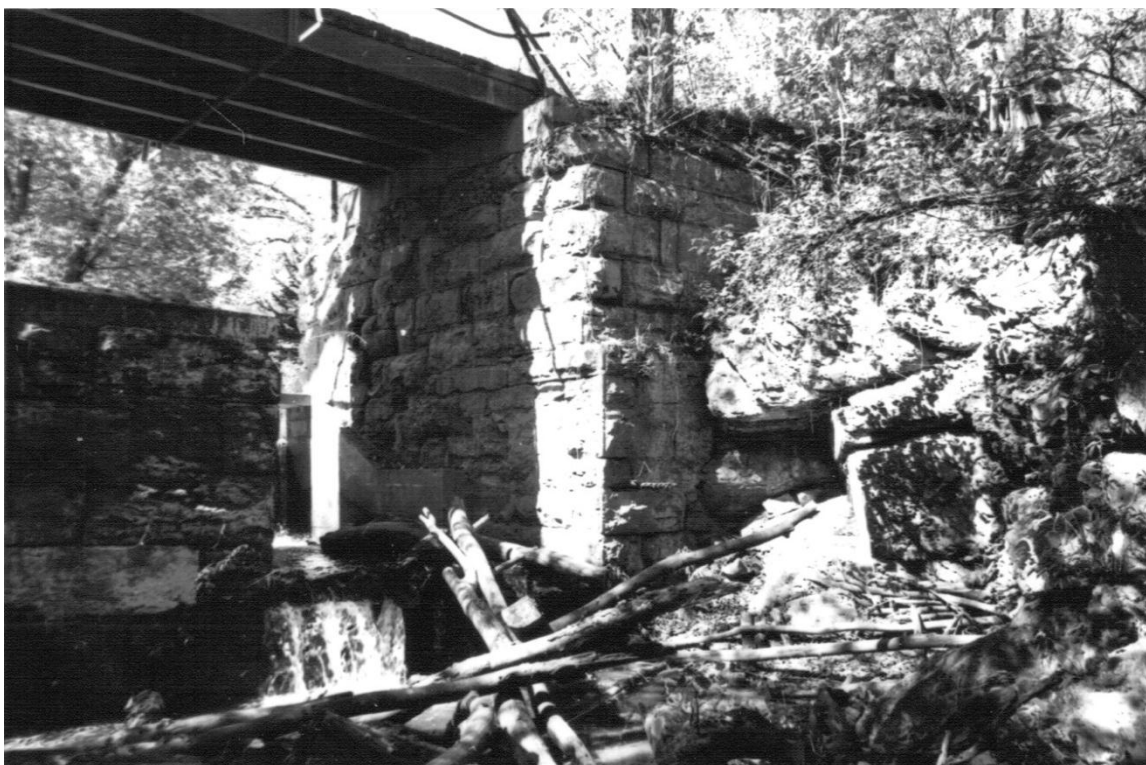
3. View of abutment at berm side facing downriver.
Note outlet of by-pass flume at bottom of photograph.

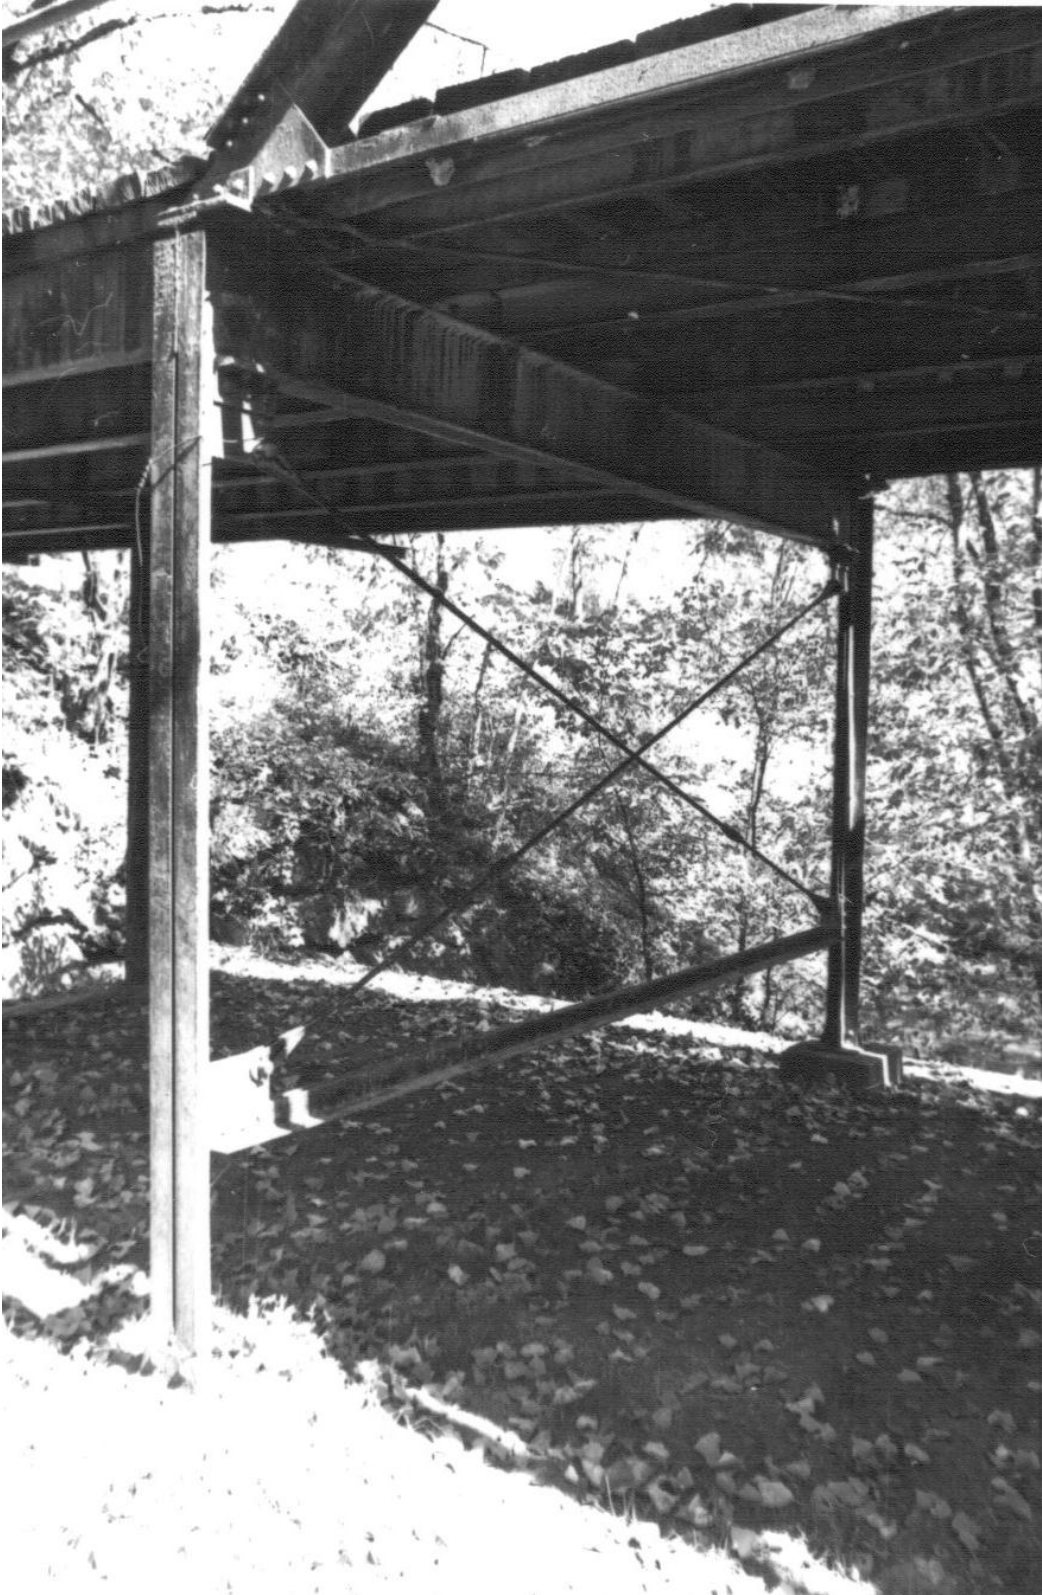
4. View of iron-column and tie-rod network between two different structural systems, the trussed span and the simple beam-and-post span.

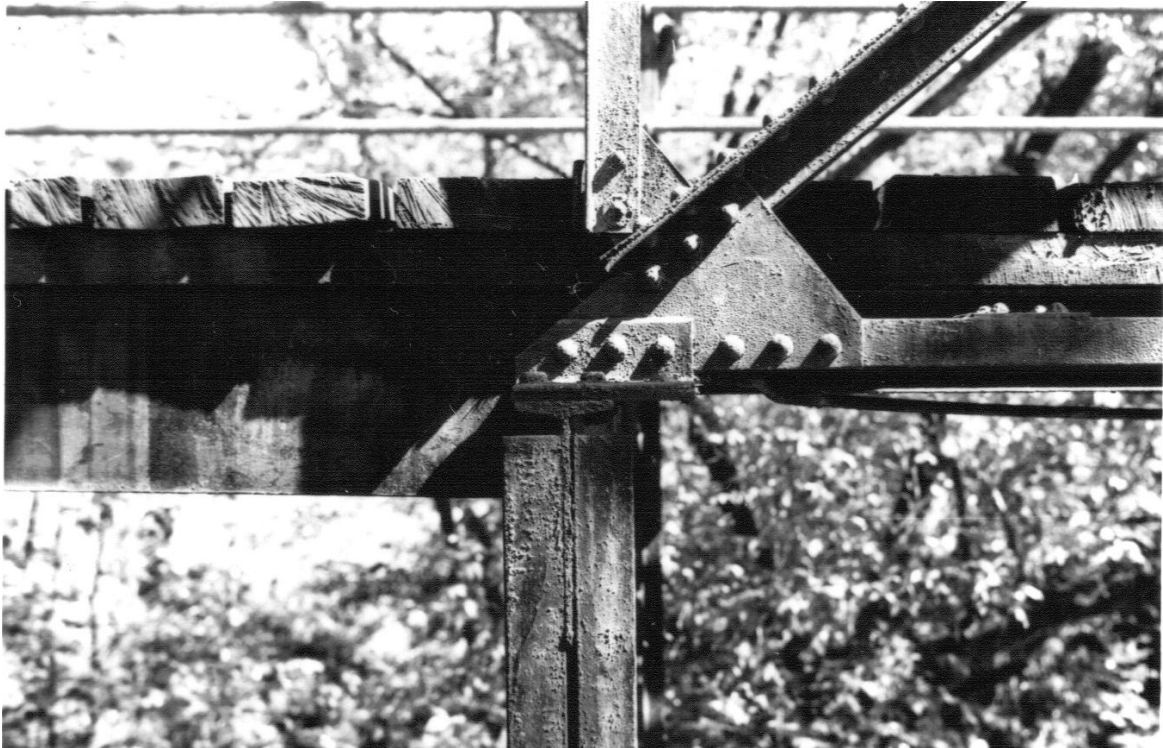
5. Connection detail showing transition between the trussed span and the simple beam-and-post span.

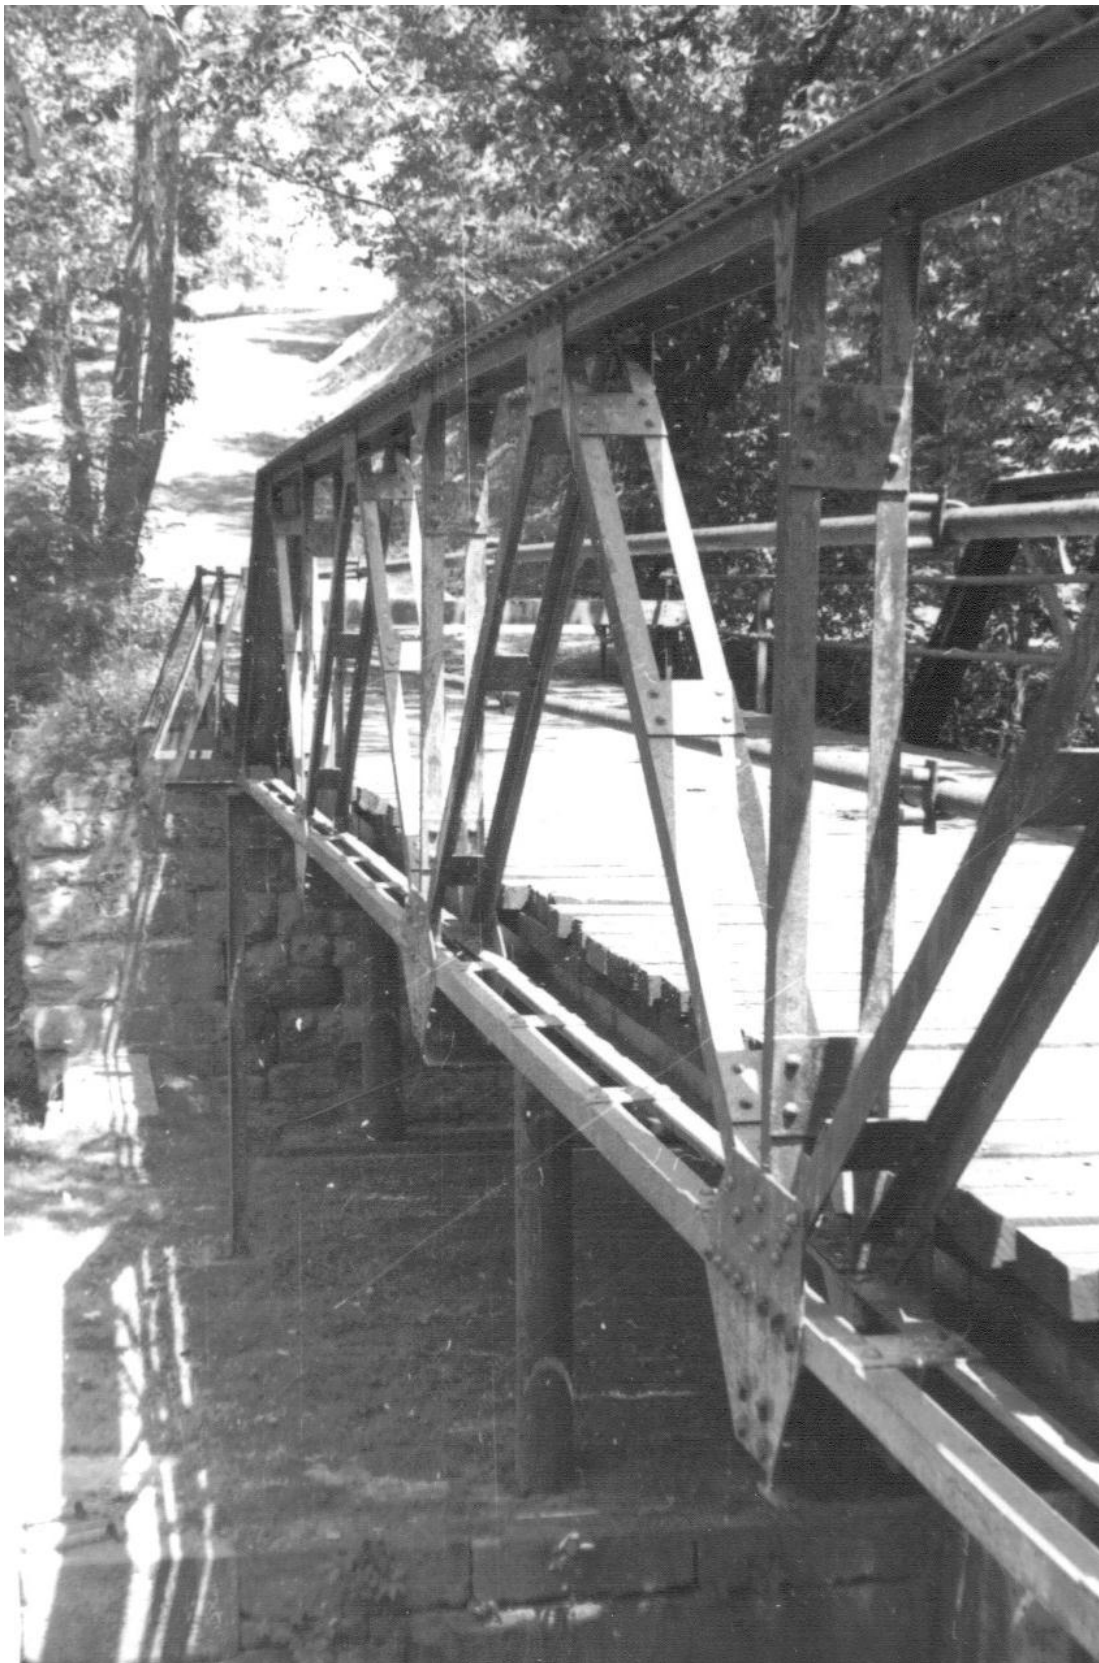
6. Side view of the inter-connecting members of the modified warren truss facing upriver.

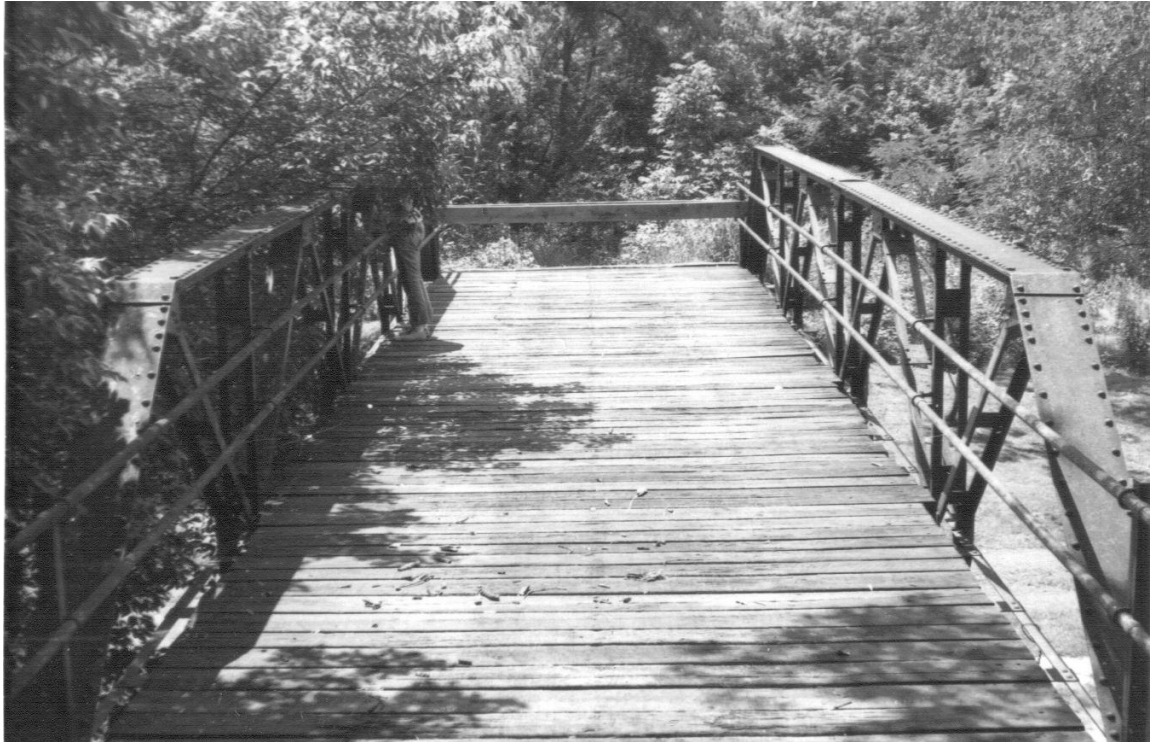
7. Top view of the iron bridge showing top chords of trusses, railings and decking.

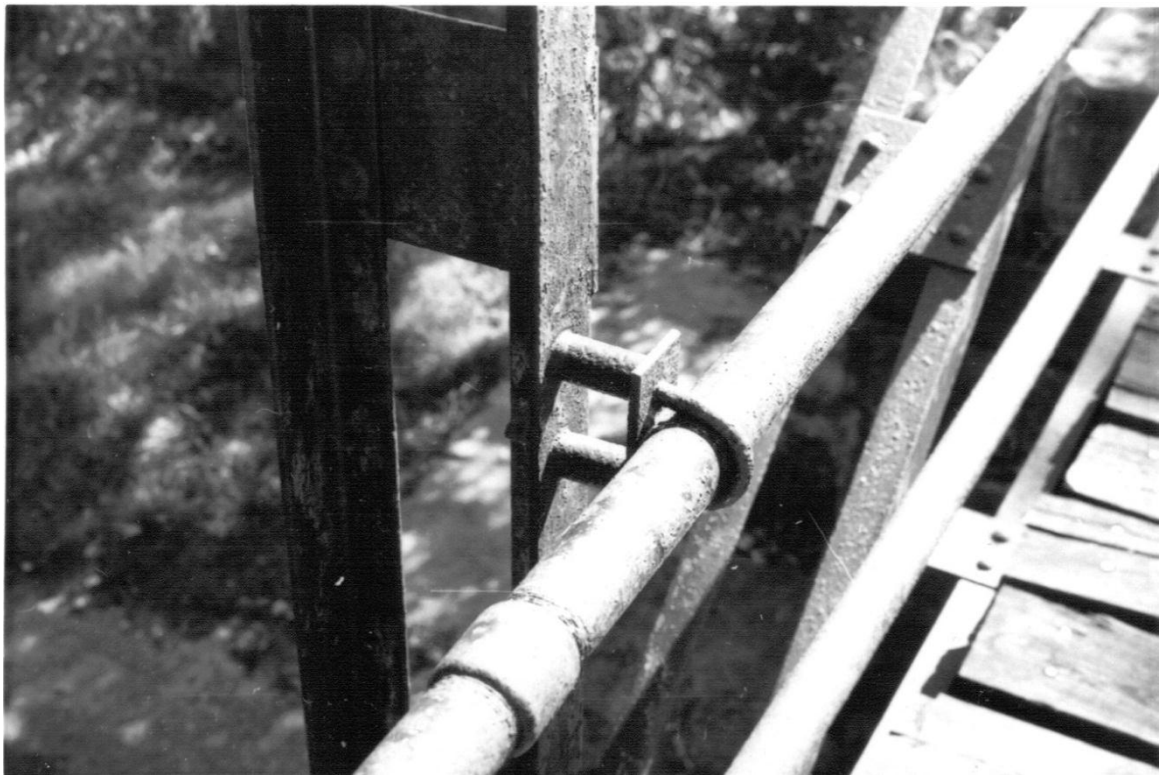
8. Detail showing how railings are fastened to vertical members of the truss.

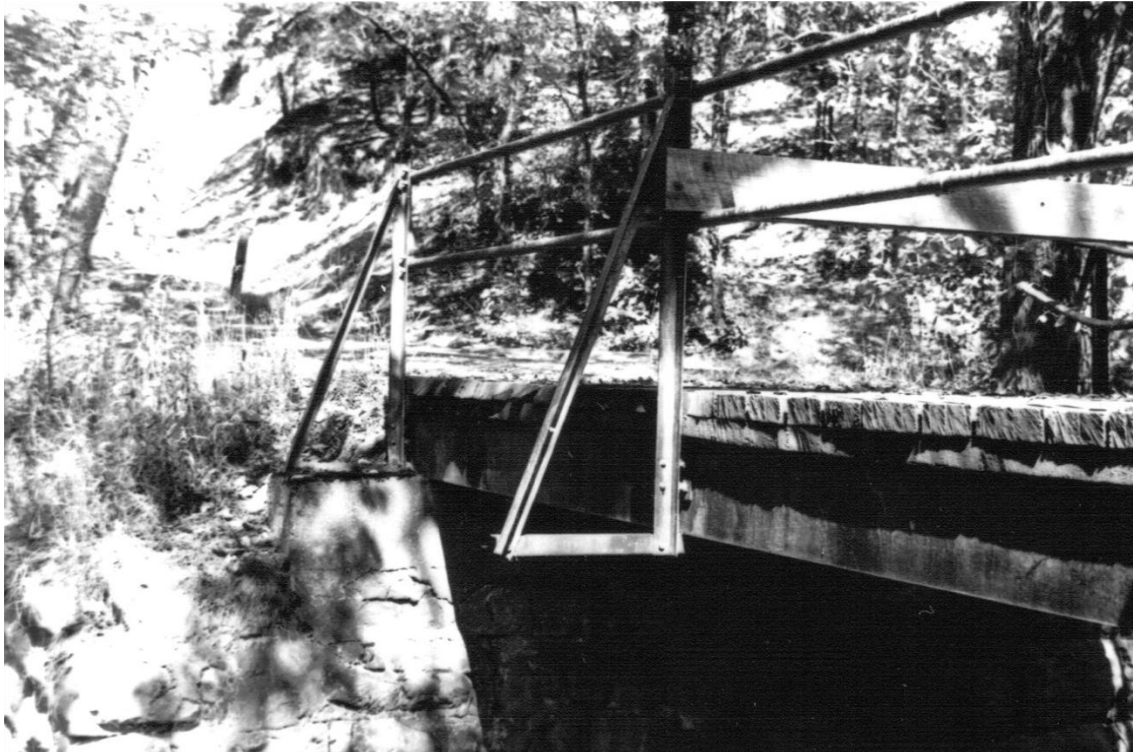
9. View of railing support at the simple beam-and-post span.

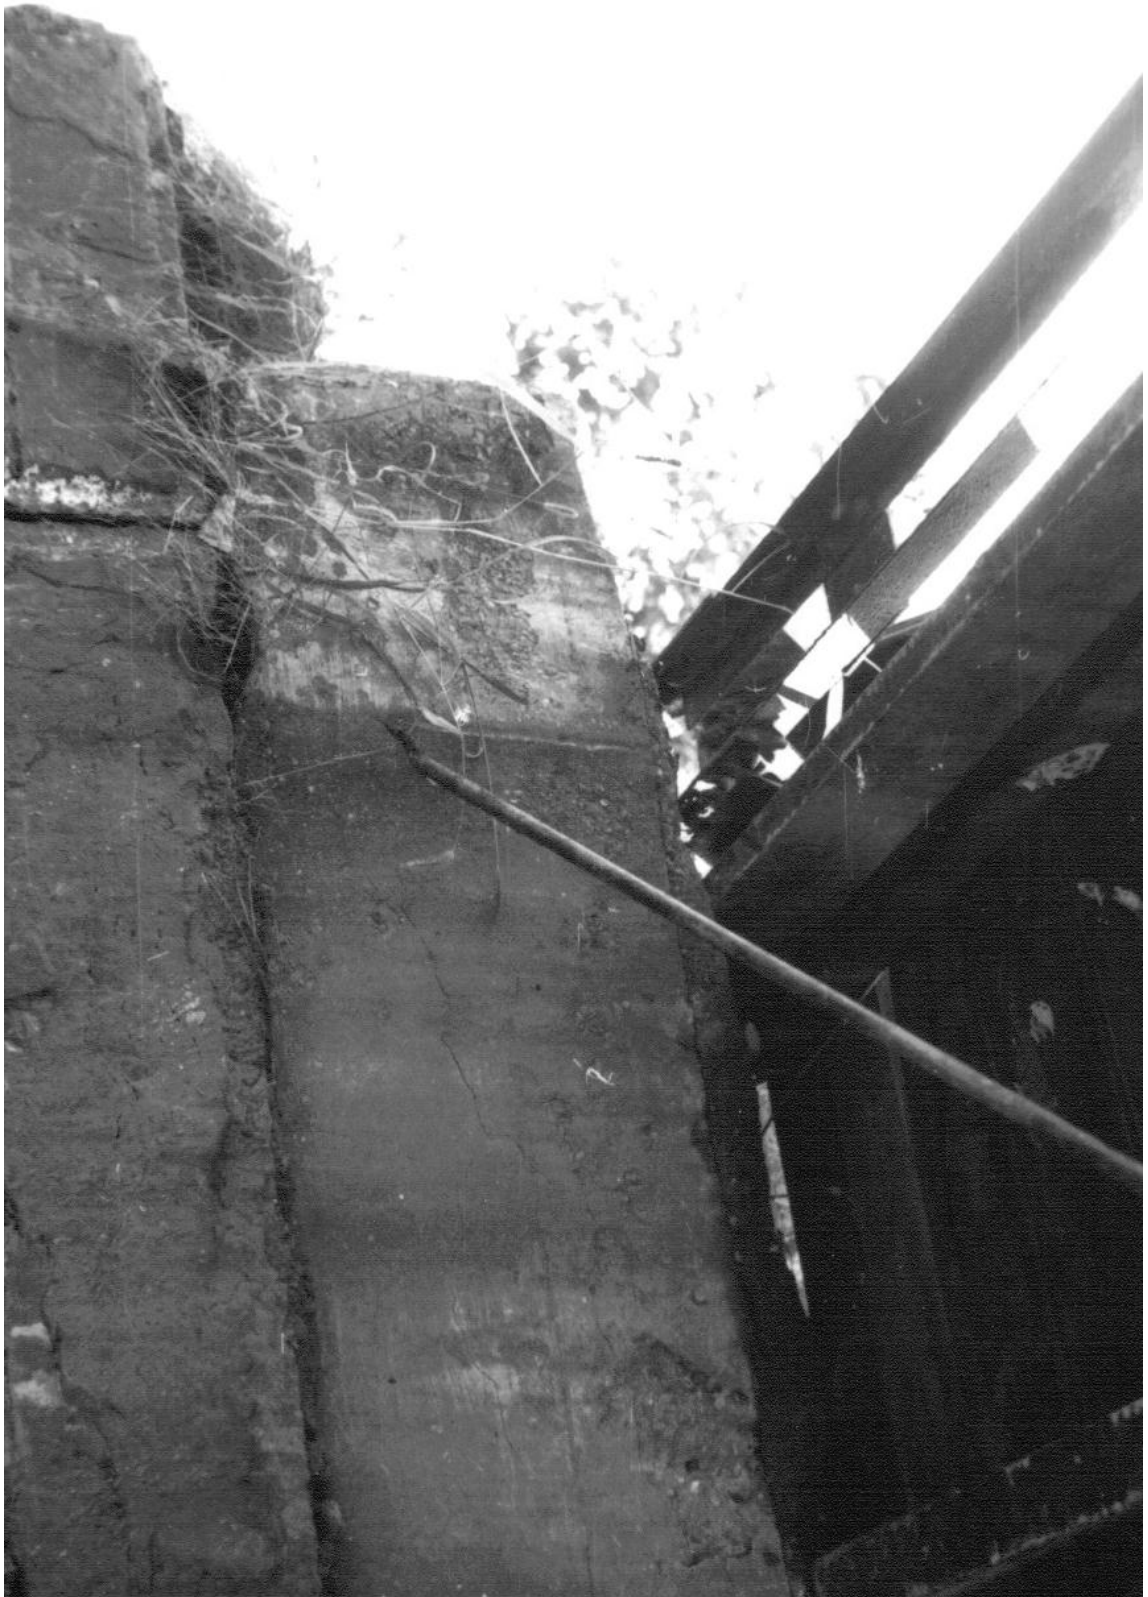
10. View showing one of obvious rust damages on the bridge.
Note that the end of the tie-rod has been rusted through.

The bridge at Lock No. 68 will be given a "face lift". Rust will be removed and a fresh coat of paint will be applied. Loose tie-rods found underneath the decking and the bent portion of the railings will be repaired. Any rotten or missing planks of three-inch by six to eight-inch white oak will be removed and replaced with sound planks. The bridge then can be re-opened to traffic with a limited weight of three tons per axle as determined to be the safe maximum load.

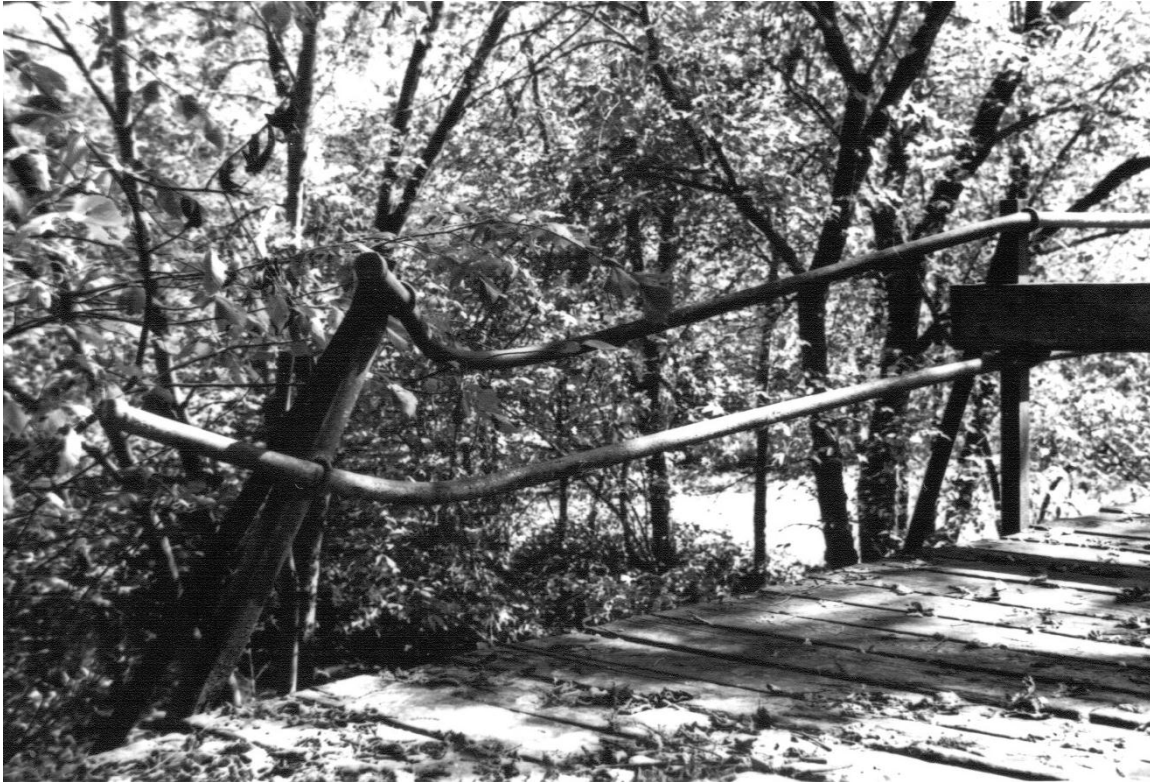
Railings of the bridge transverse the whole length. They are two-inch pipes connected together by two and one quarter-inch long couplers. Lengths of the railing pieces vary from thirteen feet five inches to fifteen feet three inches. There are twelve long pieces on each side of the bridge with six on the top and six on the bottom. These railings are supported by all vertical members spaced from ten feet one inch to thirteen feet six and one half inches apart along the length of the bridge. The bottom railings are approximately one foot nine inches above the decking and the top railings are three feet one and one half inches above. A section of the railings, at the berm side of the bridge facing downstream, bends outward from the decking to a distance of about two feet.

11. View of bent-up railing and support at the berm side of the bridge facing downriver.
